Active Filter Type N3R  
200/250A Active Filter

DRN. BY MJS DATE 6/27/16 DWG. NO. B 29938  
SCALE N/A APRVD. SHT.1 OF 2

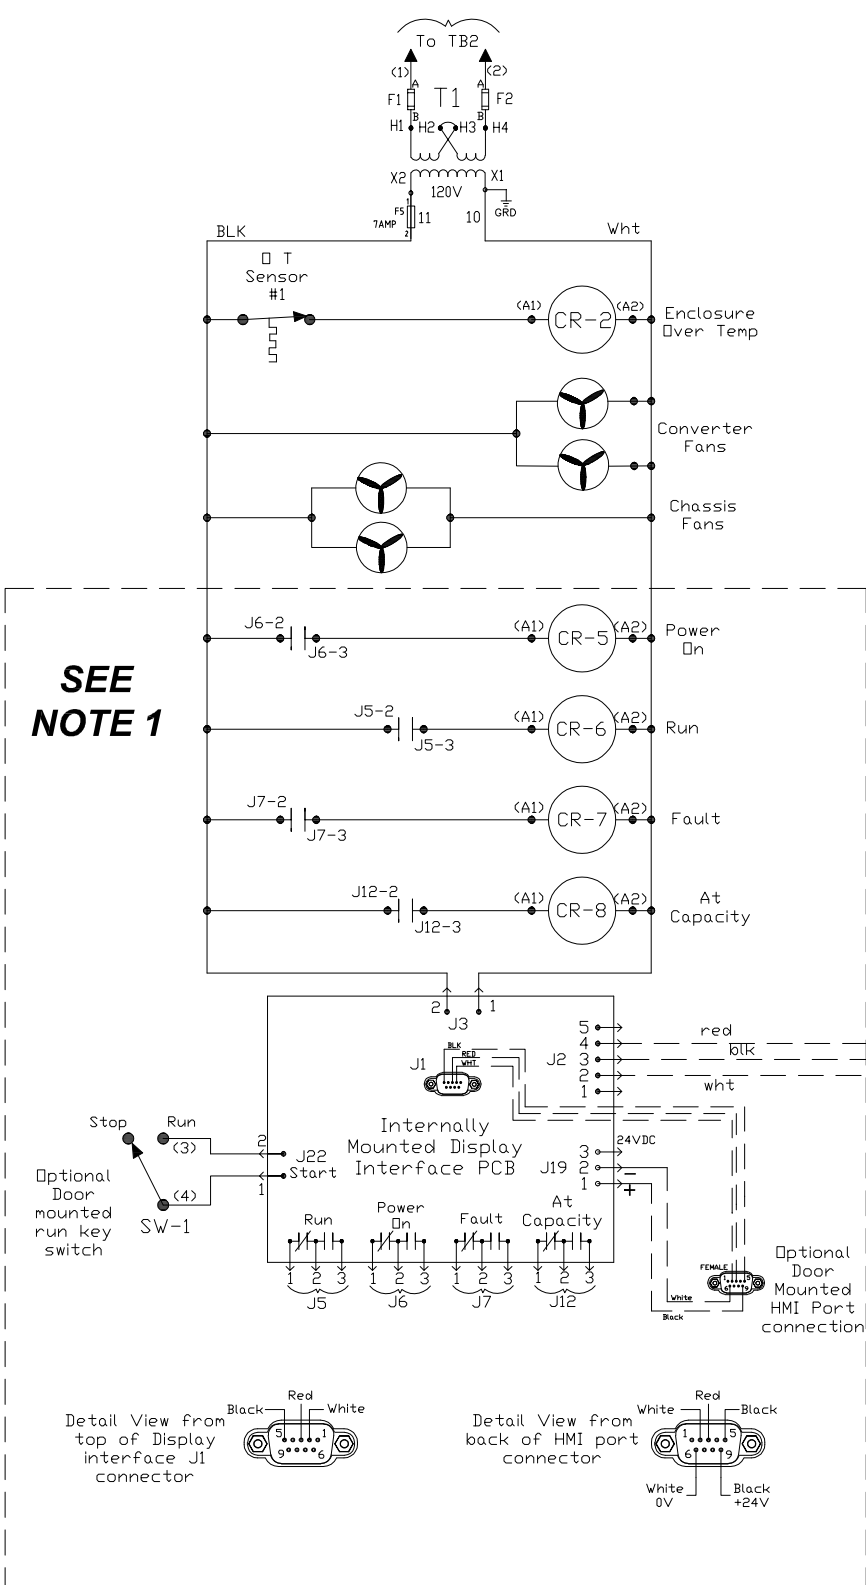
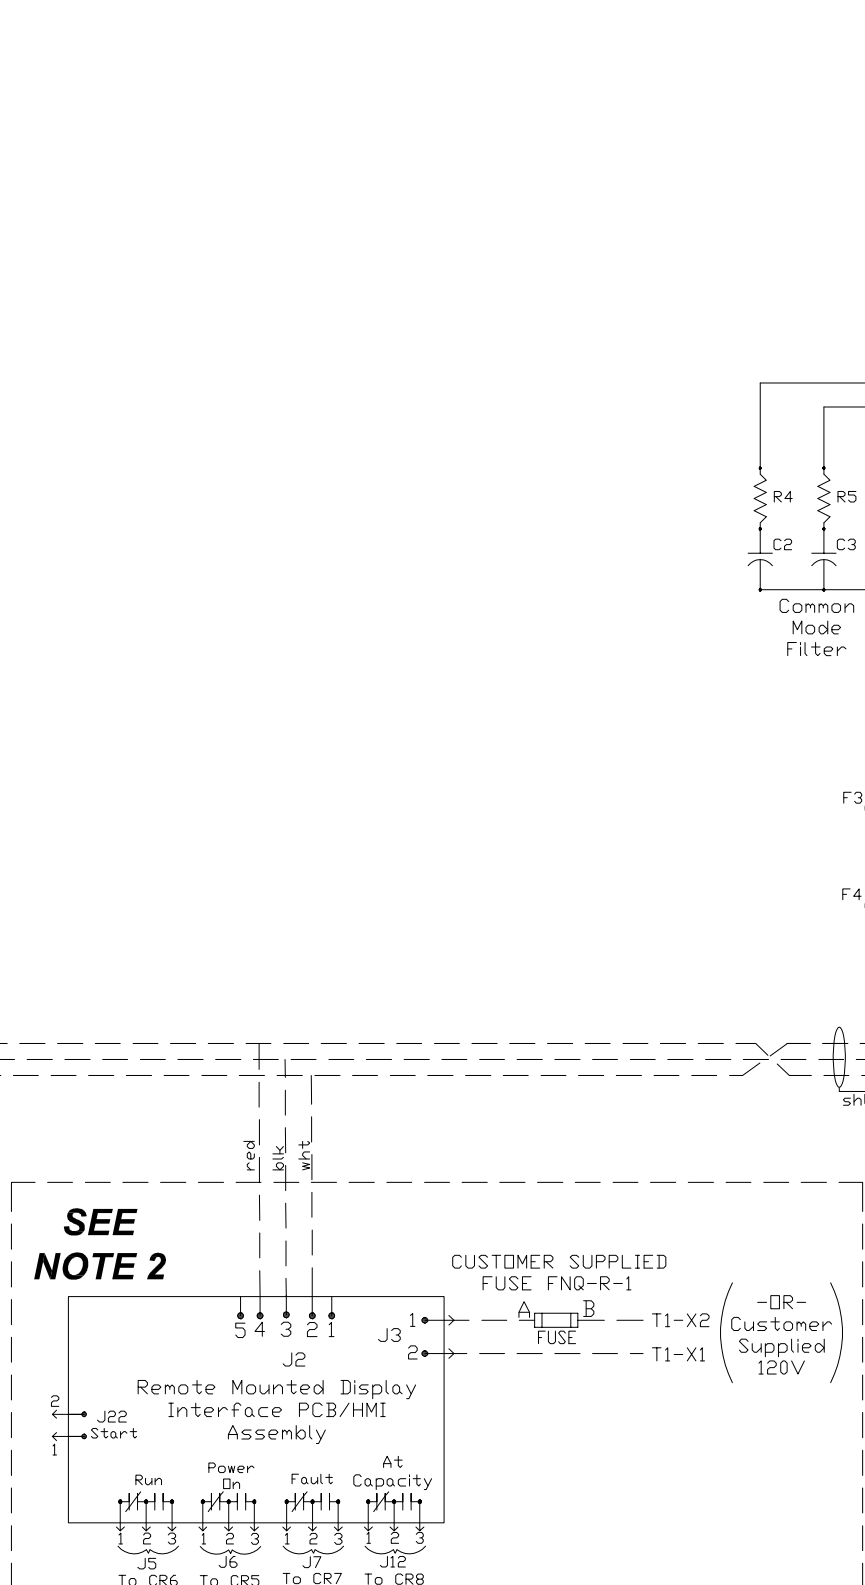
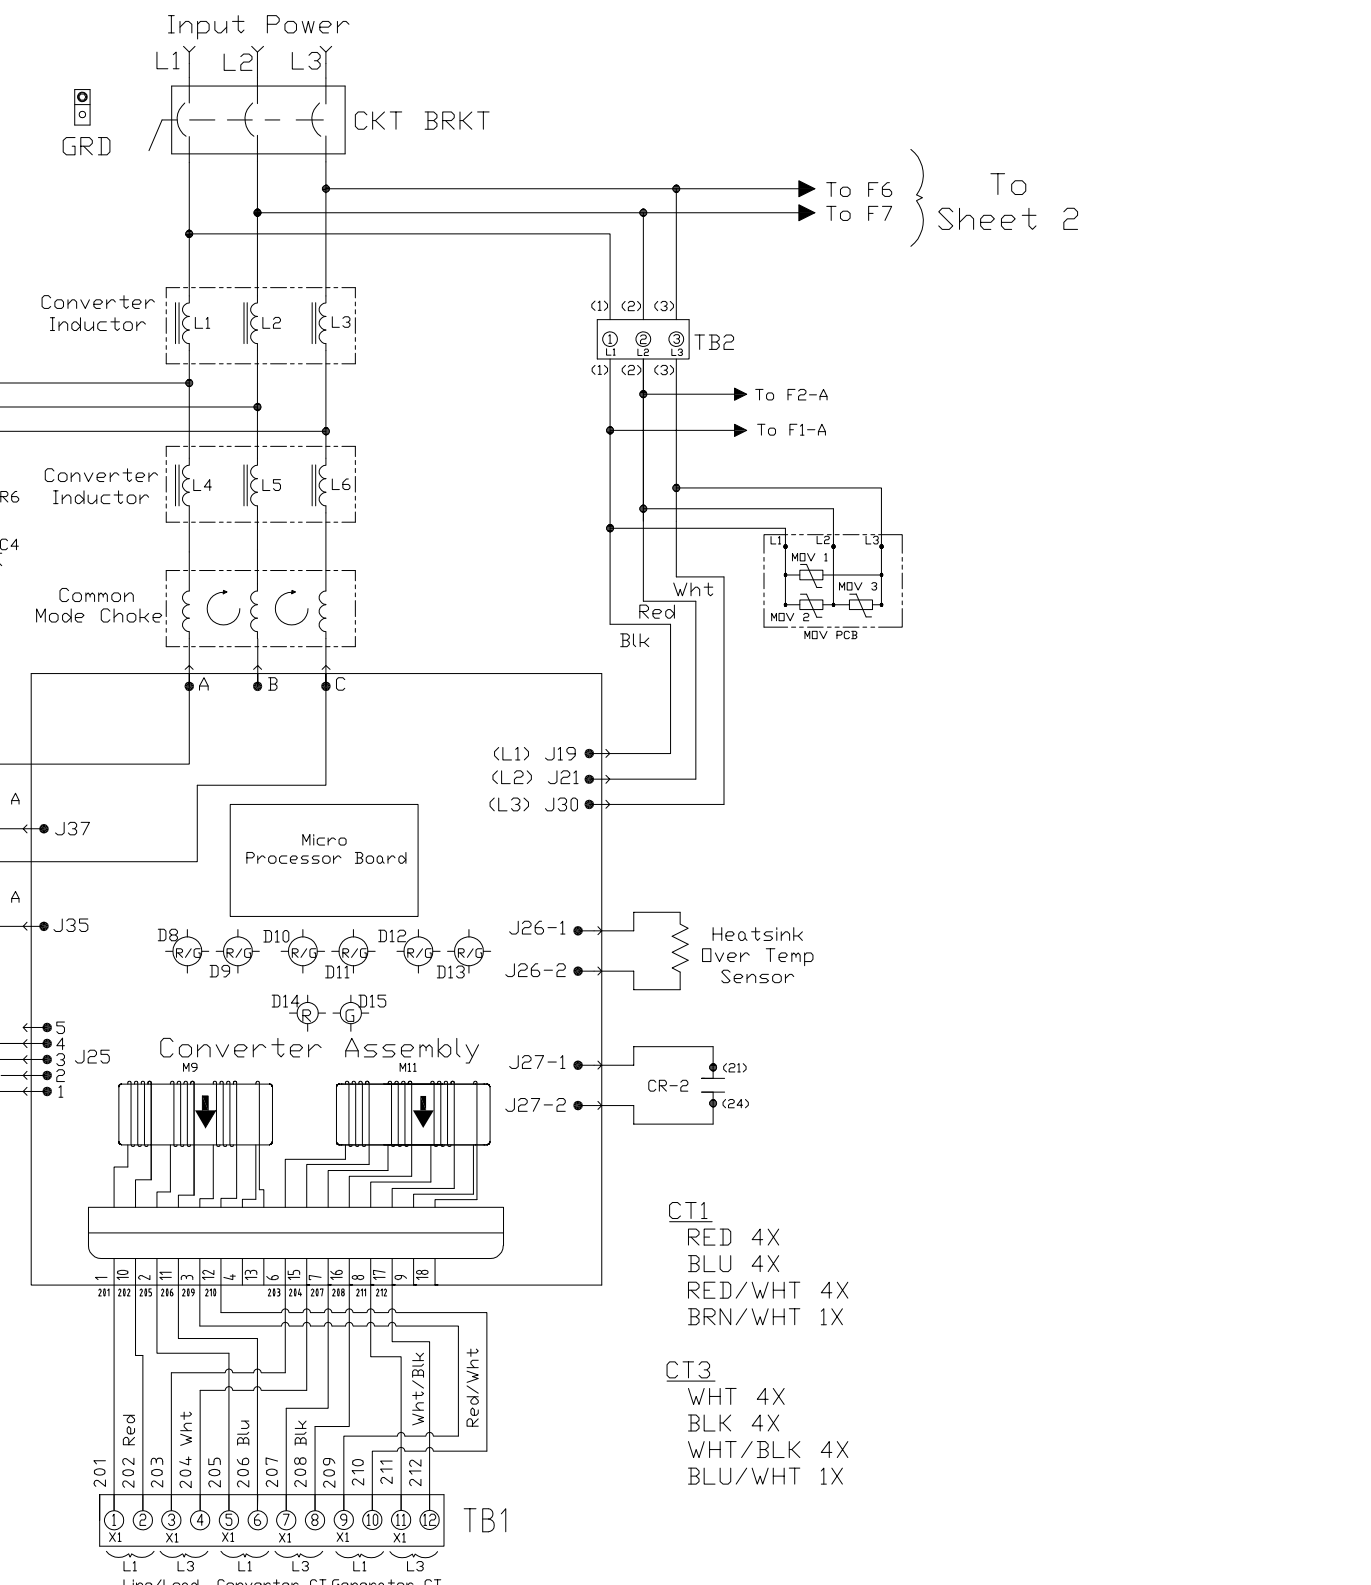
- NOTES:
- 1) DASHED LINES SURROUND OPTIONAL DISPLAY INTERFACE PCB CIRCUITRY, DOOR MOUNTED HMI CONNECTION, INDICATOR LIGHTS, AND RUN KEY SWITCH WHEN DISPLAY INTERFACE PCB IS INTERNAL TO 3R ENCLOSURE.
  - 2) OPTIONAL REMOTE MOUNTED DISPLAY INTERFACE PCB/HMI ASSEMBLY WITH CUSTOMER SUPPLIED FUSE.
  - 3.) REFER TO CUSTOMER CONNECTION DIAGRAMS 25027-3 & 28283-1.

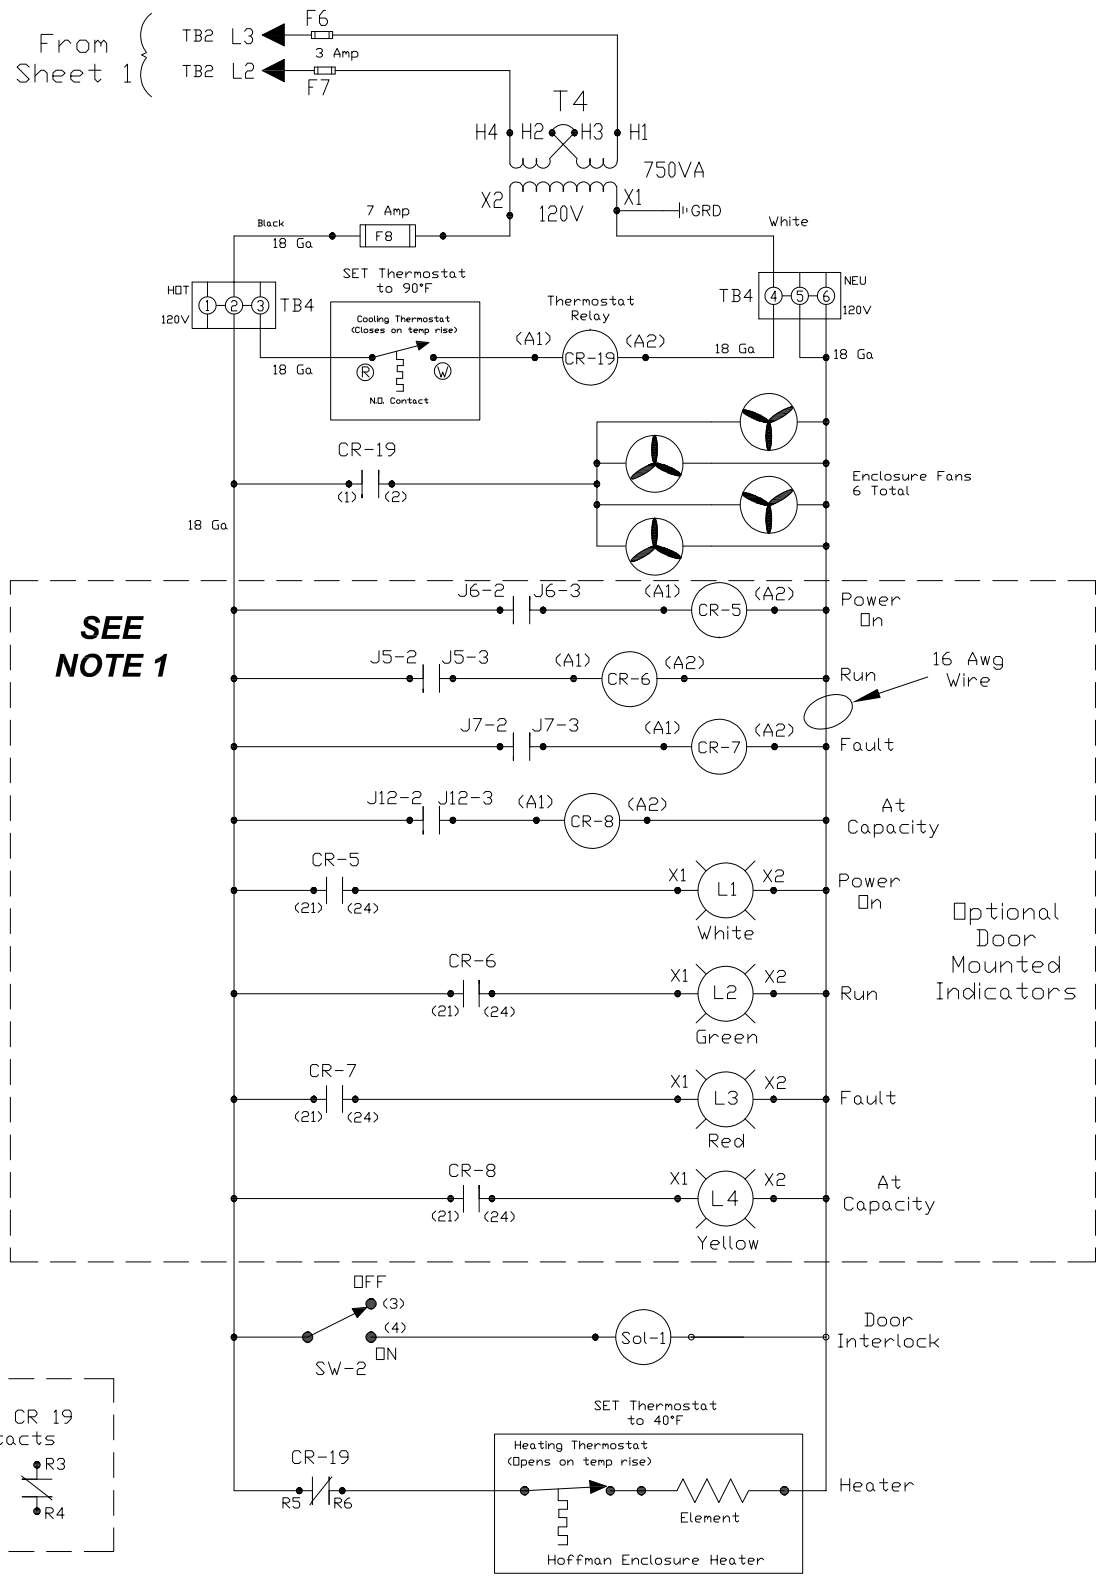
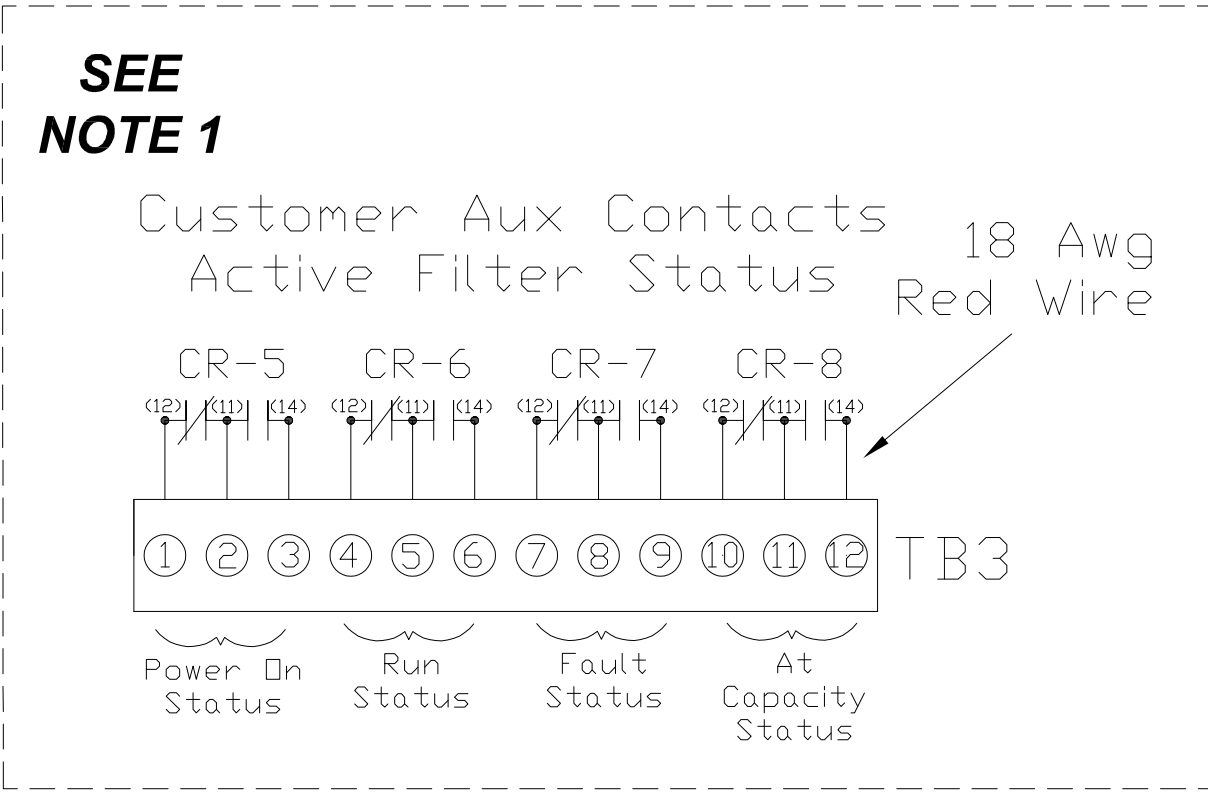
TOLERANCES (EXCEPT AS NOTED)	W132 N10611 Grant Drive Germantown, WI 53022
				DECIMAL	
				.XX ±.03 .XXX±.010	
				FRACTIONAL ± 1/32	
	SEE PG 1 FOR REV			ANGULAR ± 1°	DRN. BY MJS DATE 6/27/17 DWG. NO. 29938
NO	REVISION	DATE	BY		SCALE N/A APRVD. B SHT. 2 OF 2

1) DASHED LINES SURROUND OPTIONAL DISPLAY INTERFACE PCB CIRCUITRY, DOOR MOUNTED HMI CONNECTION, INDICATOR LIGHTS, AND RUN KEY SWITCH WHEN DISPLAY INTERFACE PCB IS INTERNAL TO 3R ENCLOSURE.

2) OPTIONAL REMOTE MOUNTED DISPLAY INTERFACE PCB/HMI ASSEMBLY WITH CUSTOMER SUPPLIED FUSE.
